# Executive Summary

On December 17, 2010 at 0243, Provo City Dispatch received a radio transmission from an off-duty Provo Police Officer working as a contracted security guard at the Provo Tabernacle reporting a fire at that location. The resulting fire would result in a fire loss of over 15 million dollars, and significantly damage a historical landmark. The ensuing investigation would last for 12 weeks with the final investigative report being issued on March 31, 2011. This is a summary of the investigative report.

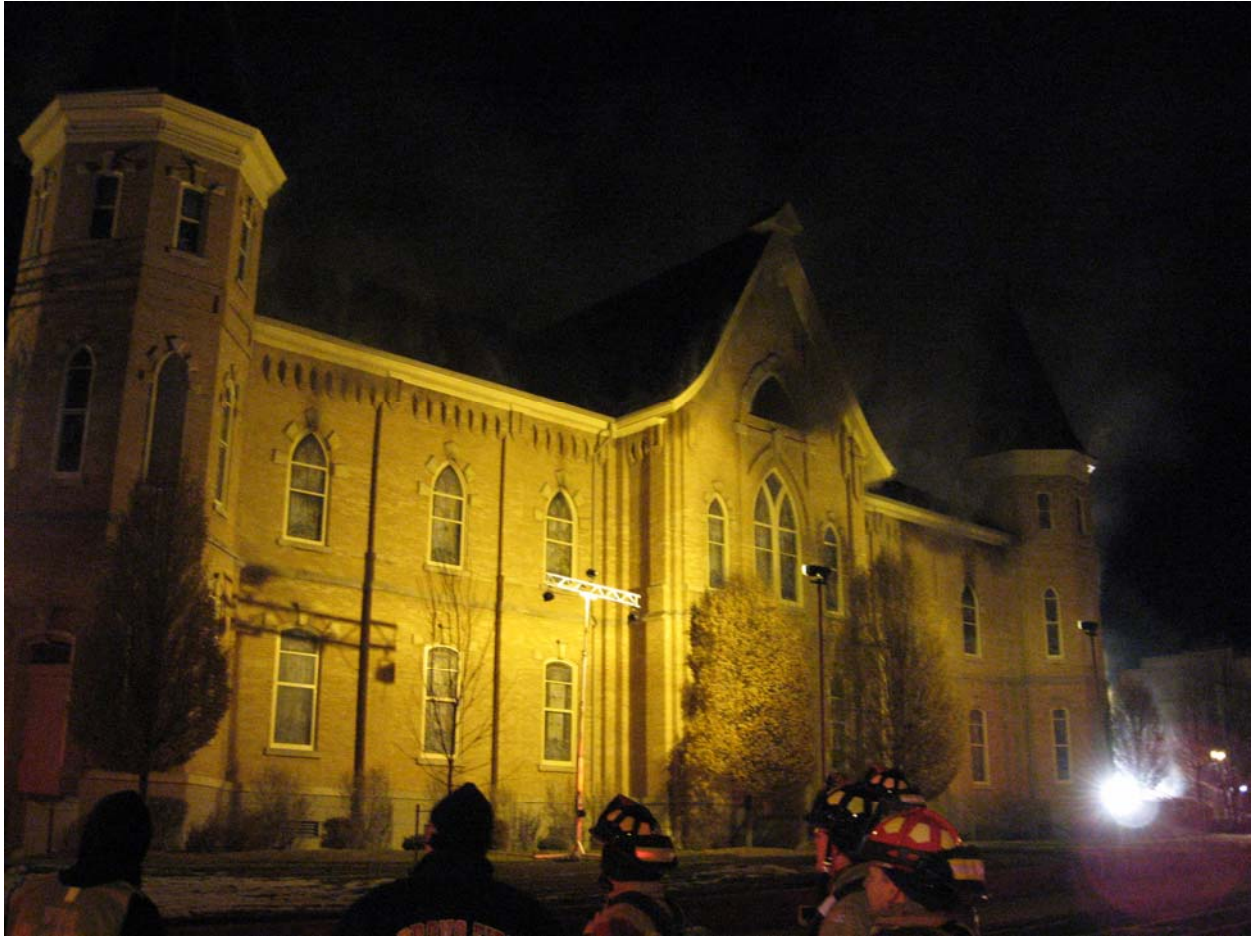
Provo Fire & Rescue received the first alarm assignment at 0243, Truck 25, who was returning to their station from another alarm and arrived at the Tabernacle at 0244. Truck 25 reported heavy smoke conditions from the gable vents. Engine 24, also returning from the previous call, reported smoke coming from the Tabernacle. A second alarm was requested. The following photograph depicts the smoke conditions presented shortly after the arrival of the first fire units.

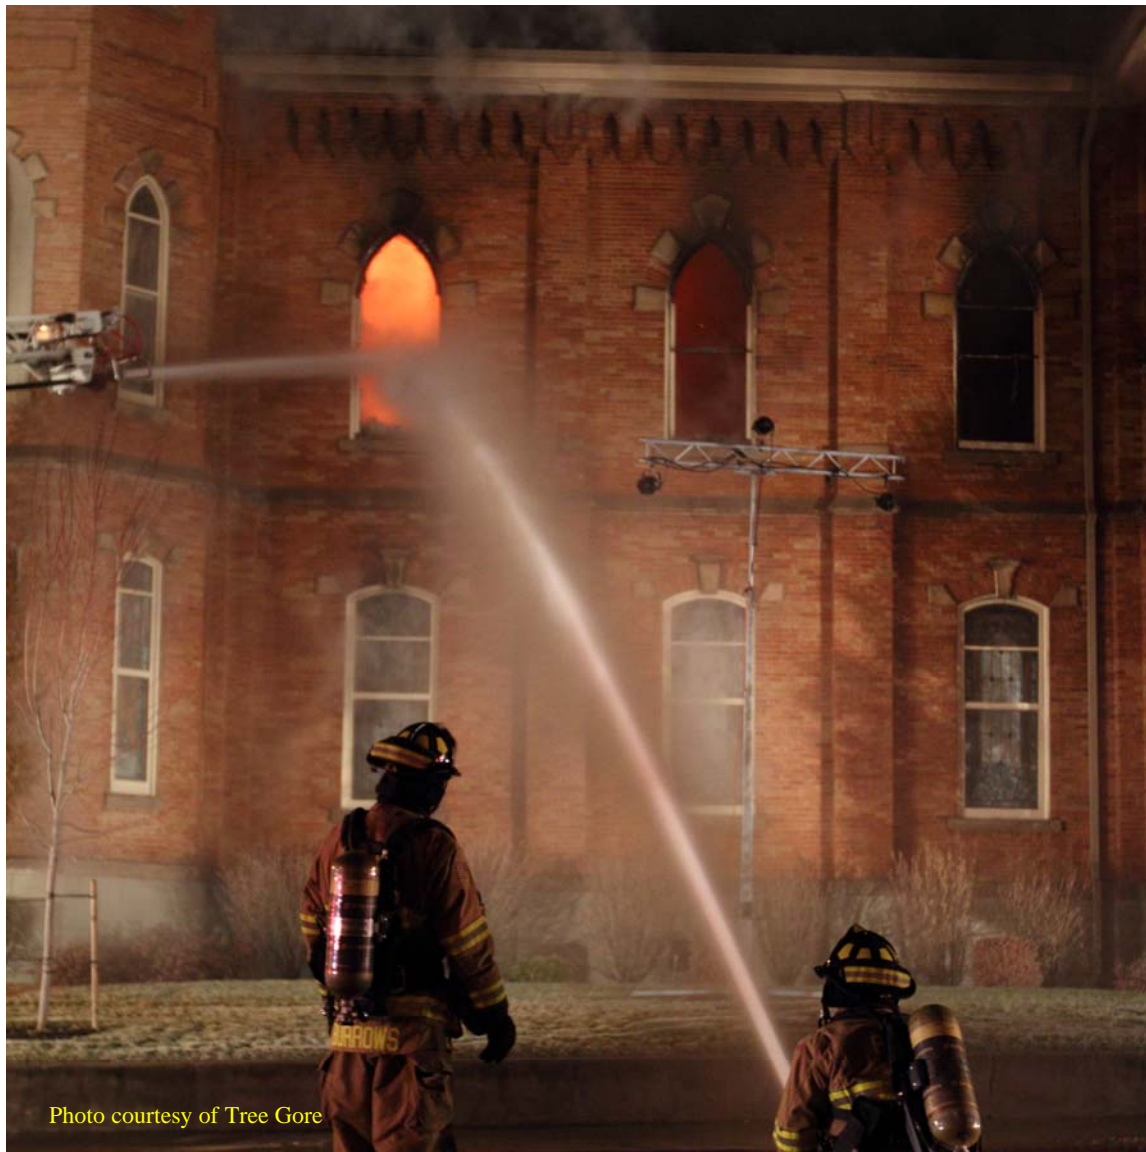
Shortly after 0305 the upper windows on the south west side of the building began to fail. As the windows began to fail flames became visible near the ceiling, pushing down out of the attic space as shown in the following photograph.

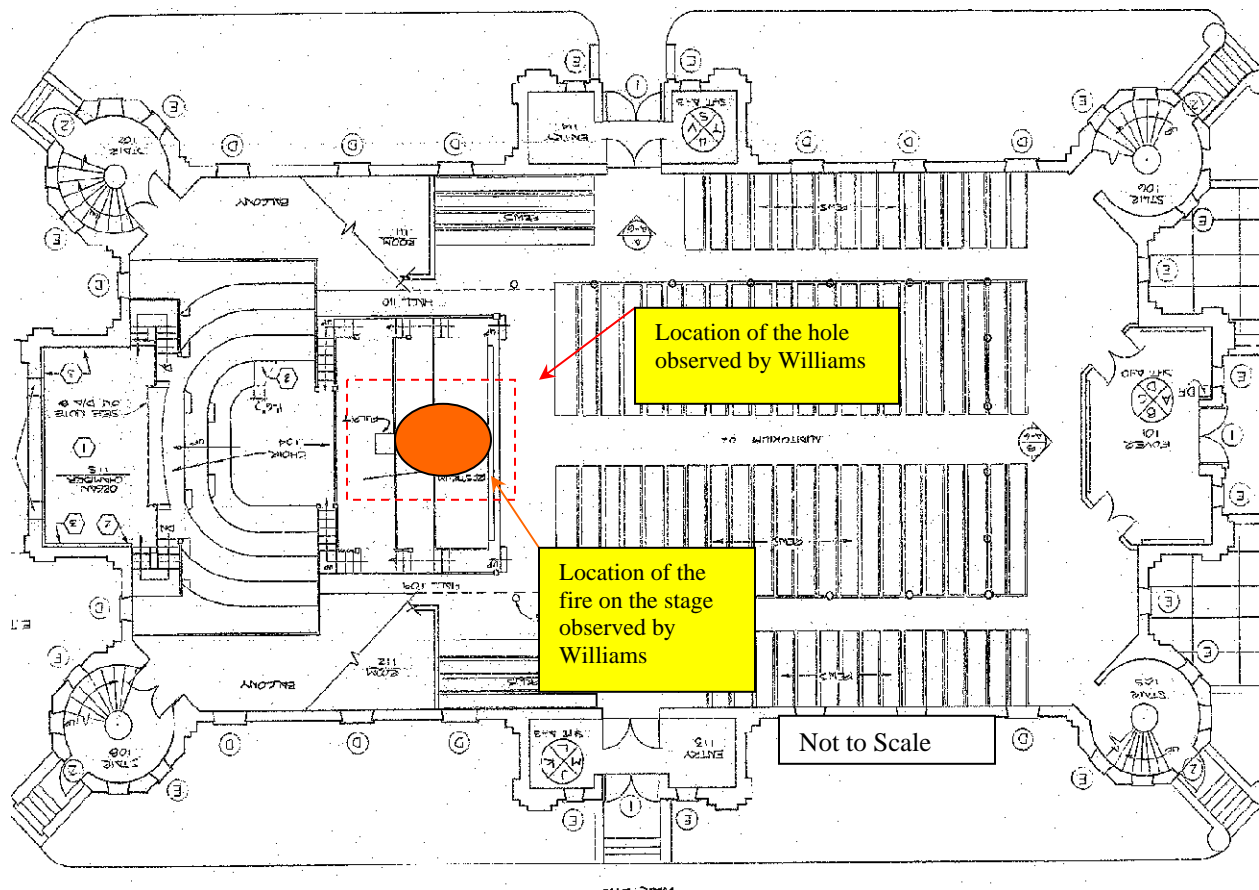
FM Schofield called the State Fire Marshals Office for assistance in determining the origin cause and circumstances of this fire. A Task Force was established for this purpose. On December 18, 2010 the Task Force met at Provo Fire Station 21 and was briefed. Following a short briefing the Task Force visited the site. The site was photographed. The Task Force then interviewed Mr. Williams, the security guard who discovered the fire, and Jeremy and Jeff Ostler, the owners of Trax Lighting and AV. Williams provided the following diagram showing where he found the fire on the stage as well as where he saw the hole in the ceiling.

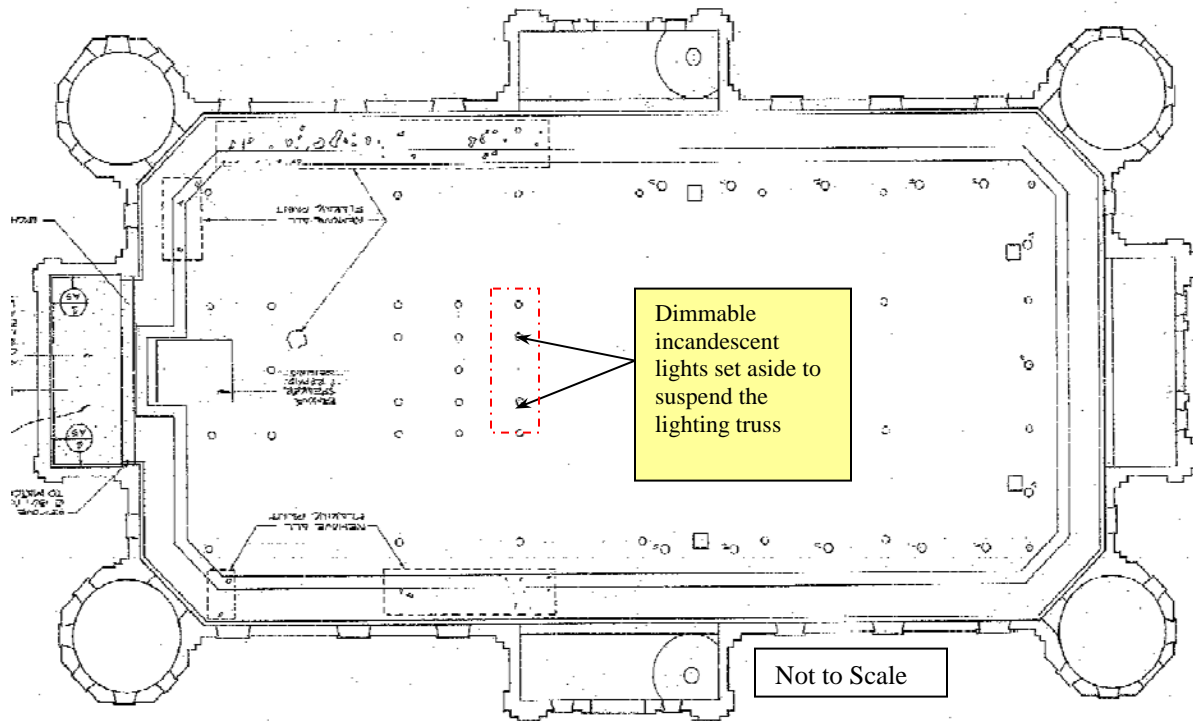
Jeremy Ostler was interviewed with his father, Jeff. They provided a lighting scheme that was to be used for the Gloria production. He provided a diagram showing the location of the suspended lighting truss and the in-house incandescent light fixtures he used with his dimmer box.

The diagram is shown on the reflected ceiling plan for clarity. The following diagram is representative of the diagram provided.

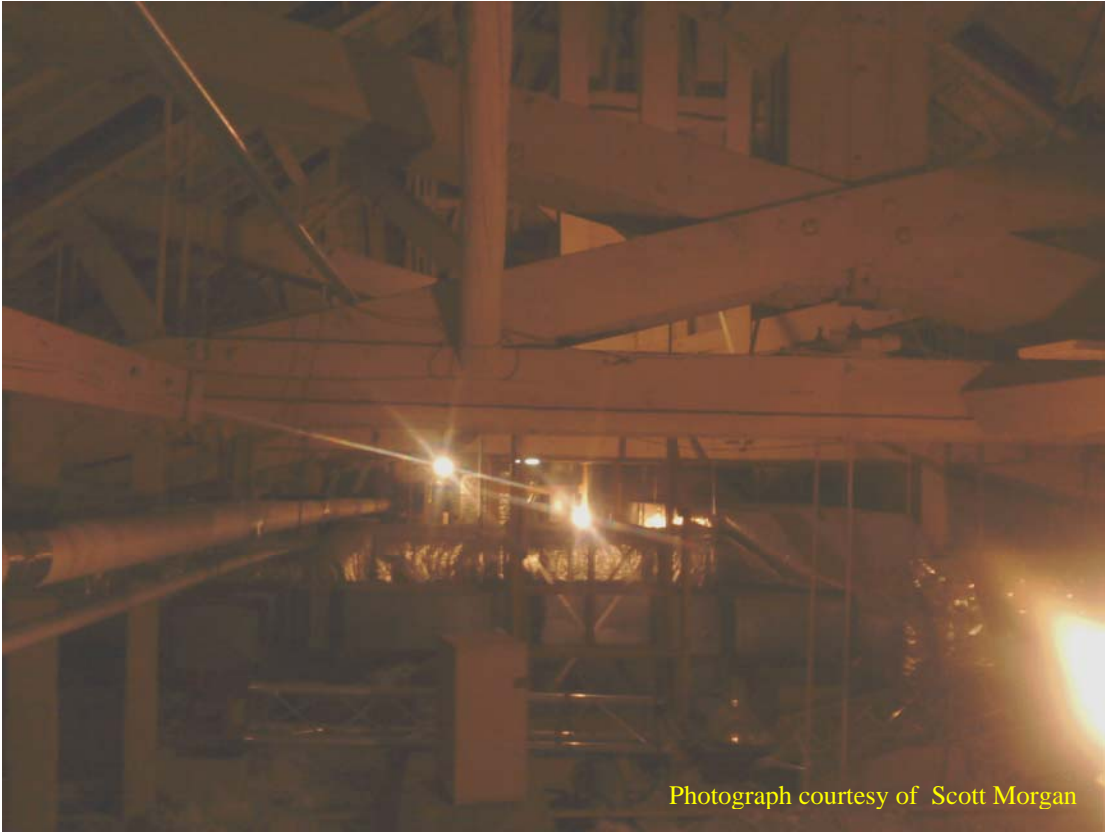
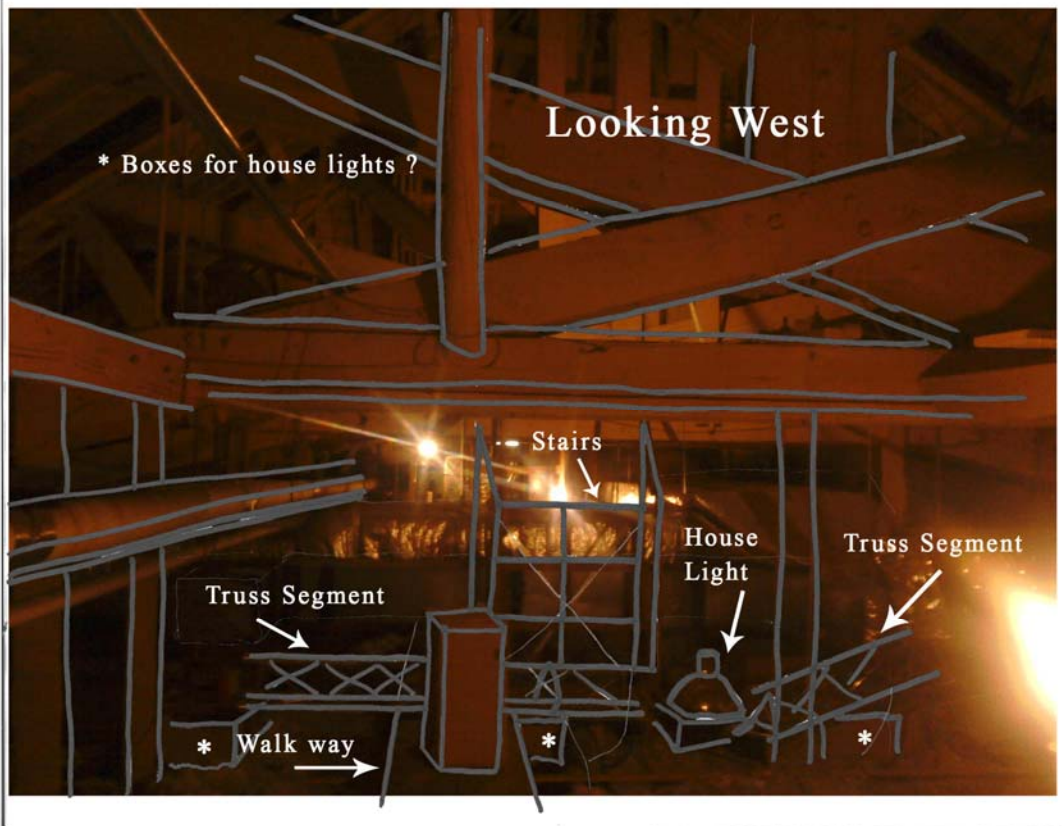
On January 3, 2011 the Task Force was able to enter into the structure to gather data and evidence that would lead to the origin and cause of this fire. Based on the interviews conducted to that point, investigators were particularly interested in the two circuits that made up the dimmable incandescent light circuits. On January 4, 2011 a second camera operator, Scott Morgan, was interviewed by members of the Task Force. Mr. Morgan indicated that he and Mr. Bunton had gone into the attic space to look at the architecture of the building. Mr. Morgan stated that he had forgotten to take his camera with him; however he did take a picture with his cell phone. Mr. Morgan provided 2 copies of the photograph, one with labeling and one without labeling. The following photographs were provided by Scott Morgan.

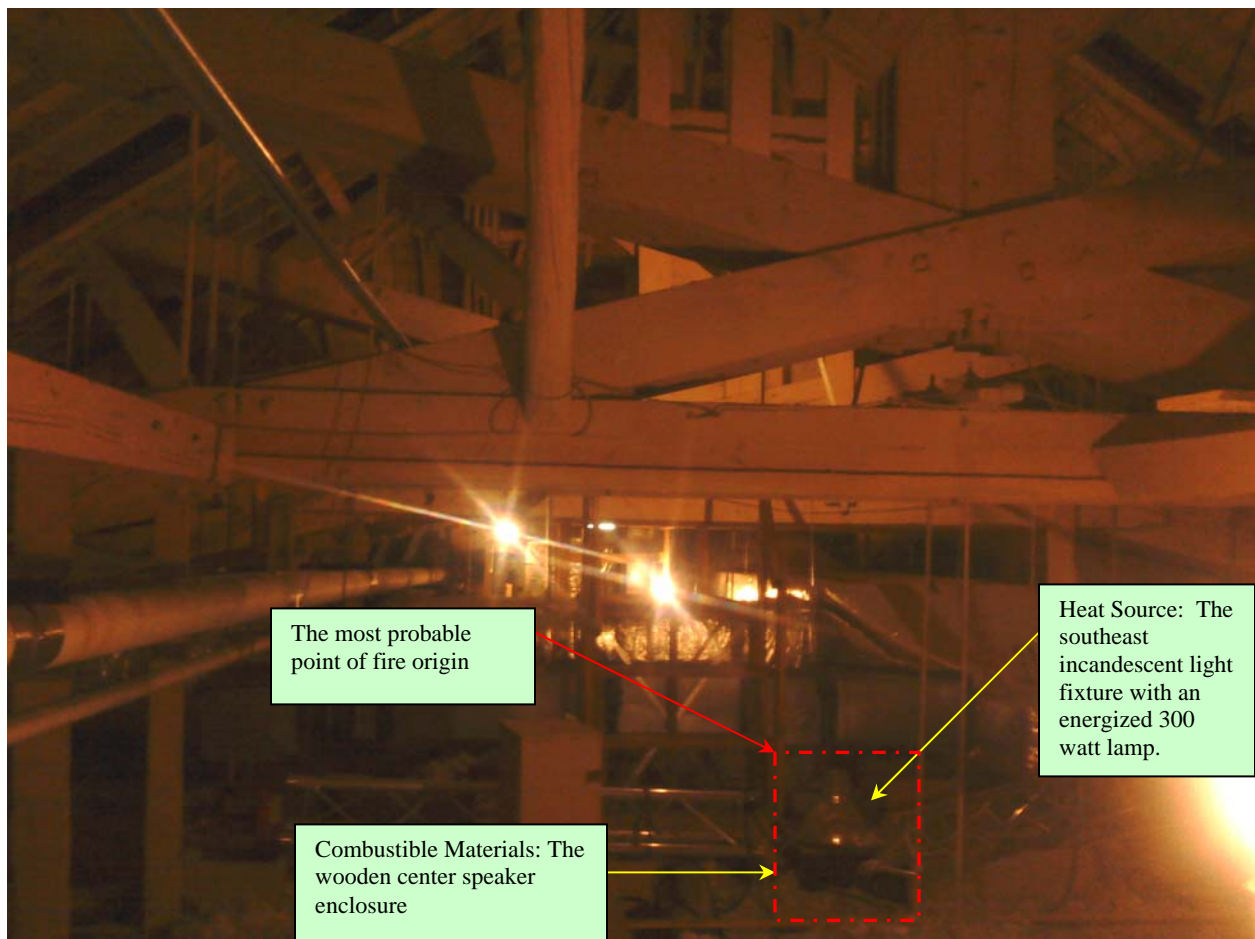
1. The most probable proximate cause of the fire at the Tabernacle December 17, 2010 is a heat source, specifically an energized 300 watt lamp, which was placed too close to combustible materials, specifically a wooden speaker enclosure.
