# Executive Summary

On December 17, 2010 at 0243, Provo City Dispatch received a radio transmission from an off-duty Provo Police Officer working as a contracted security guard at the Provo Tabernacle reporting a fire at that location. The resulting fire would result in a fire loss of over 15 million dollars, and significantly damage a historical landmark. The ensuing investigation would last for 12 weeks with the final investigative report being issued on March 31, 2011. This is a summary of the investigative report.

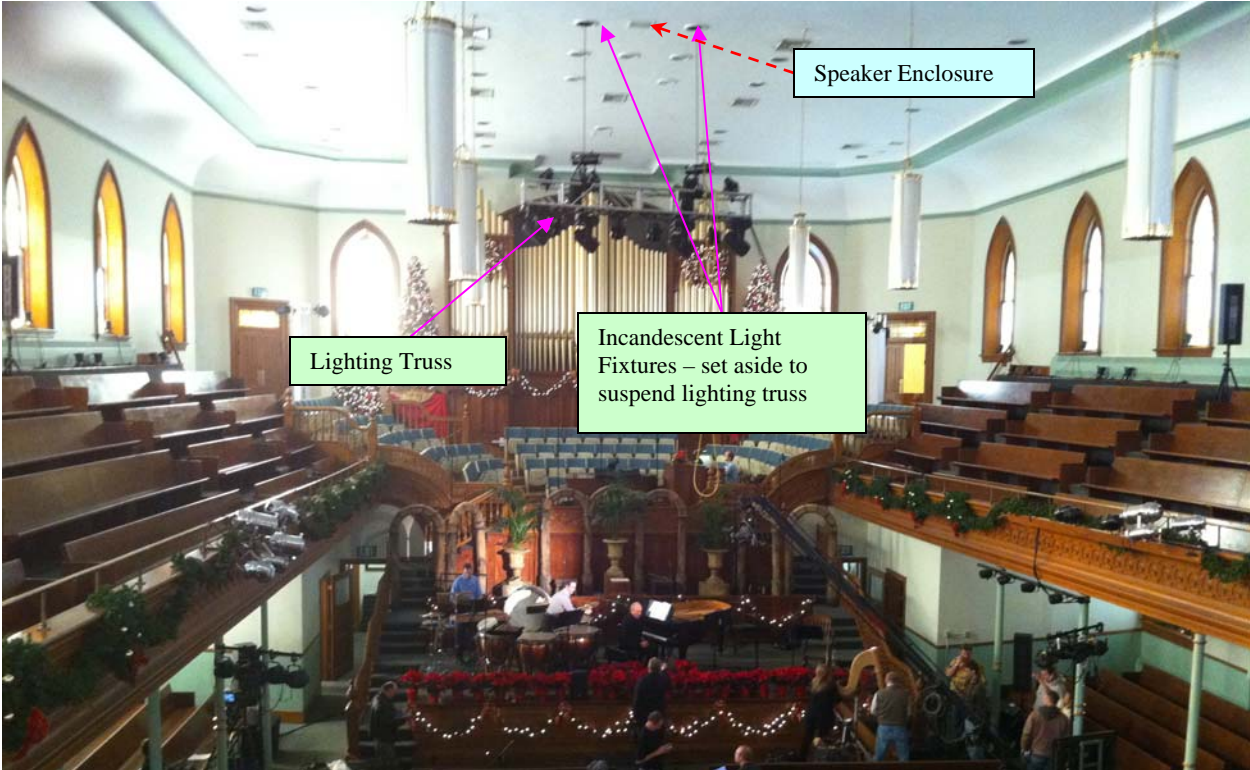
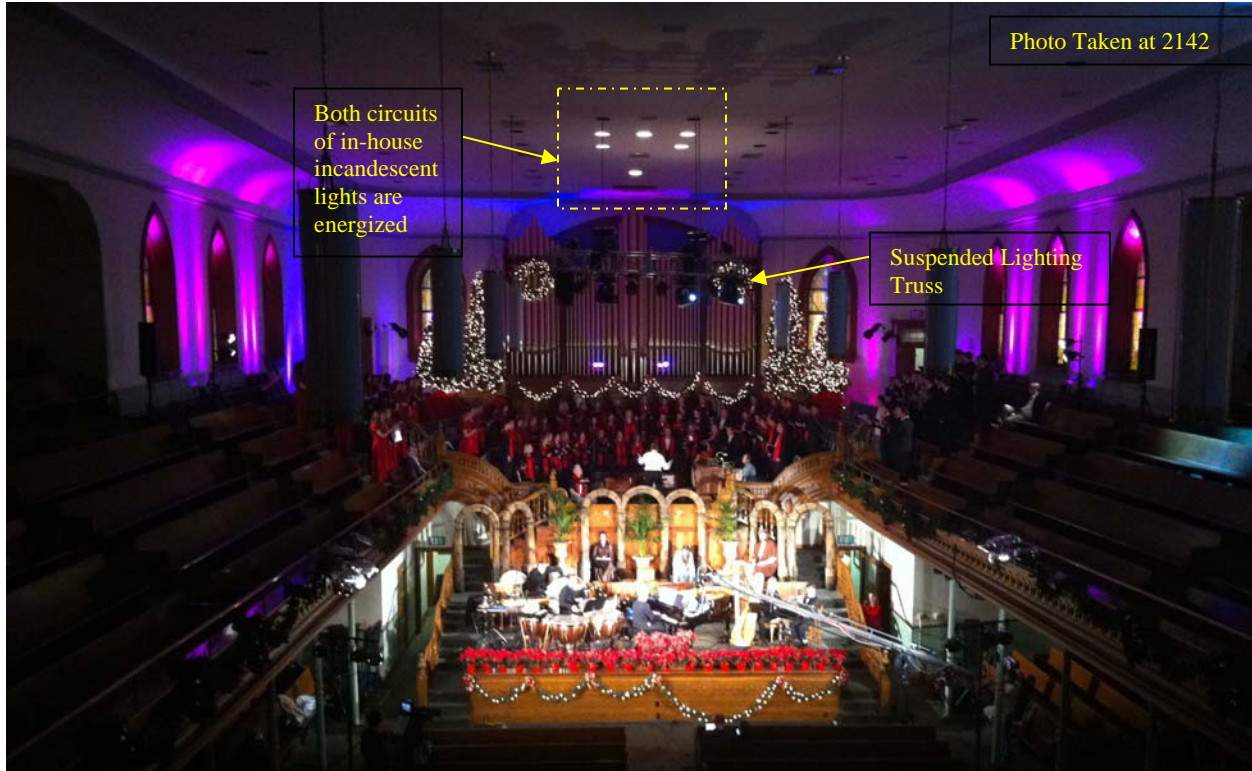
He reported that there was nothing unusual. The following photographs show the production lighting for the Gloria Production, Thursday afternoon and again at 2142 Thursday evening.
